Technical Report CHL-98-8
March 1998

Navigation Conditions at Saugus River Floodgate

Prepared for U.S. Army Engineer Division, New England

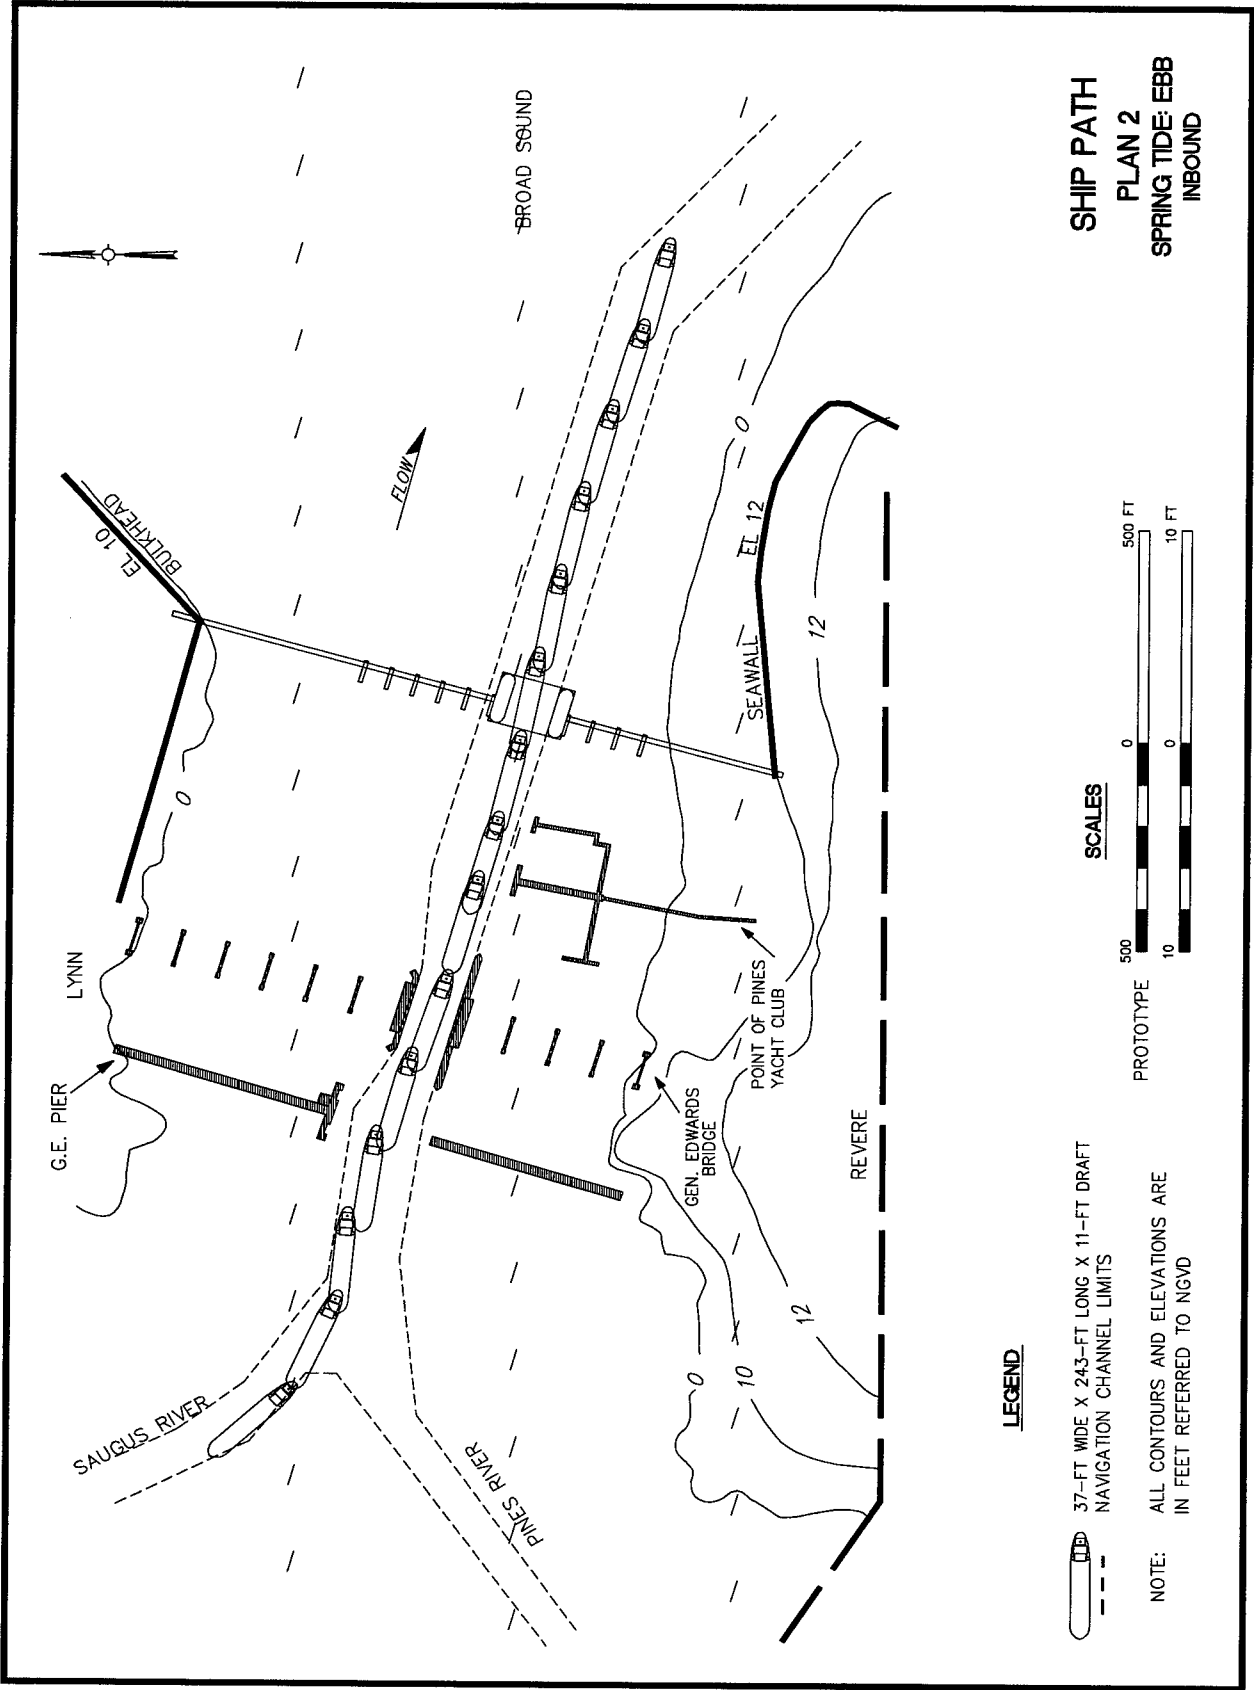
Plate 34

Navigation conditions were satisfactory for inbound tankers with the spring tide and ebb flow (Plate 34). Inbound tankers approaching the navigation gate were required to take a set into the flow, enter the navigation gate, and proceed toward the GEB. As previously mentioned, the flow between the two structures is fairly straight and navigation conditions were improved compared with those of Plan 1. Navigation conditions exiting the GEB were very similar to those observed with all other tests.

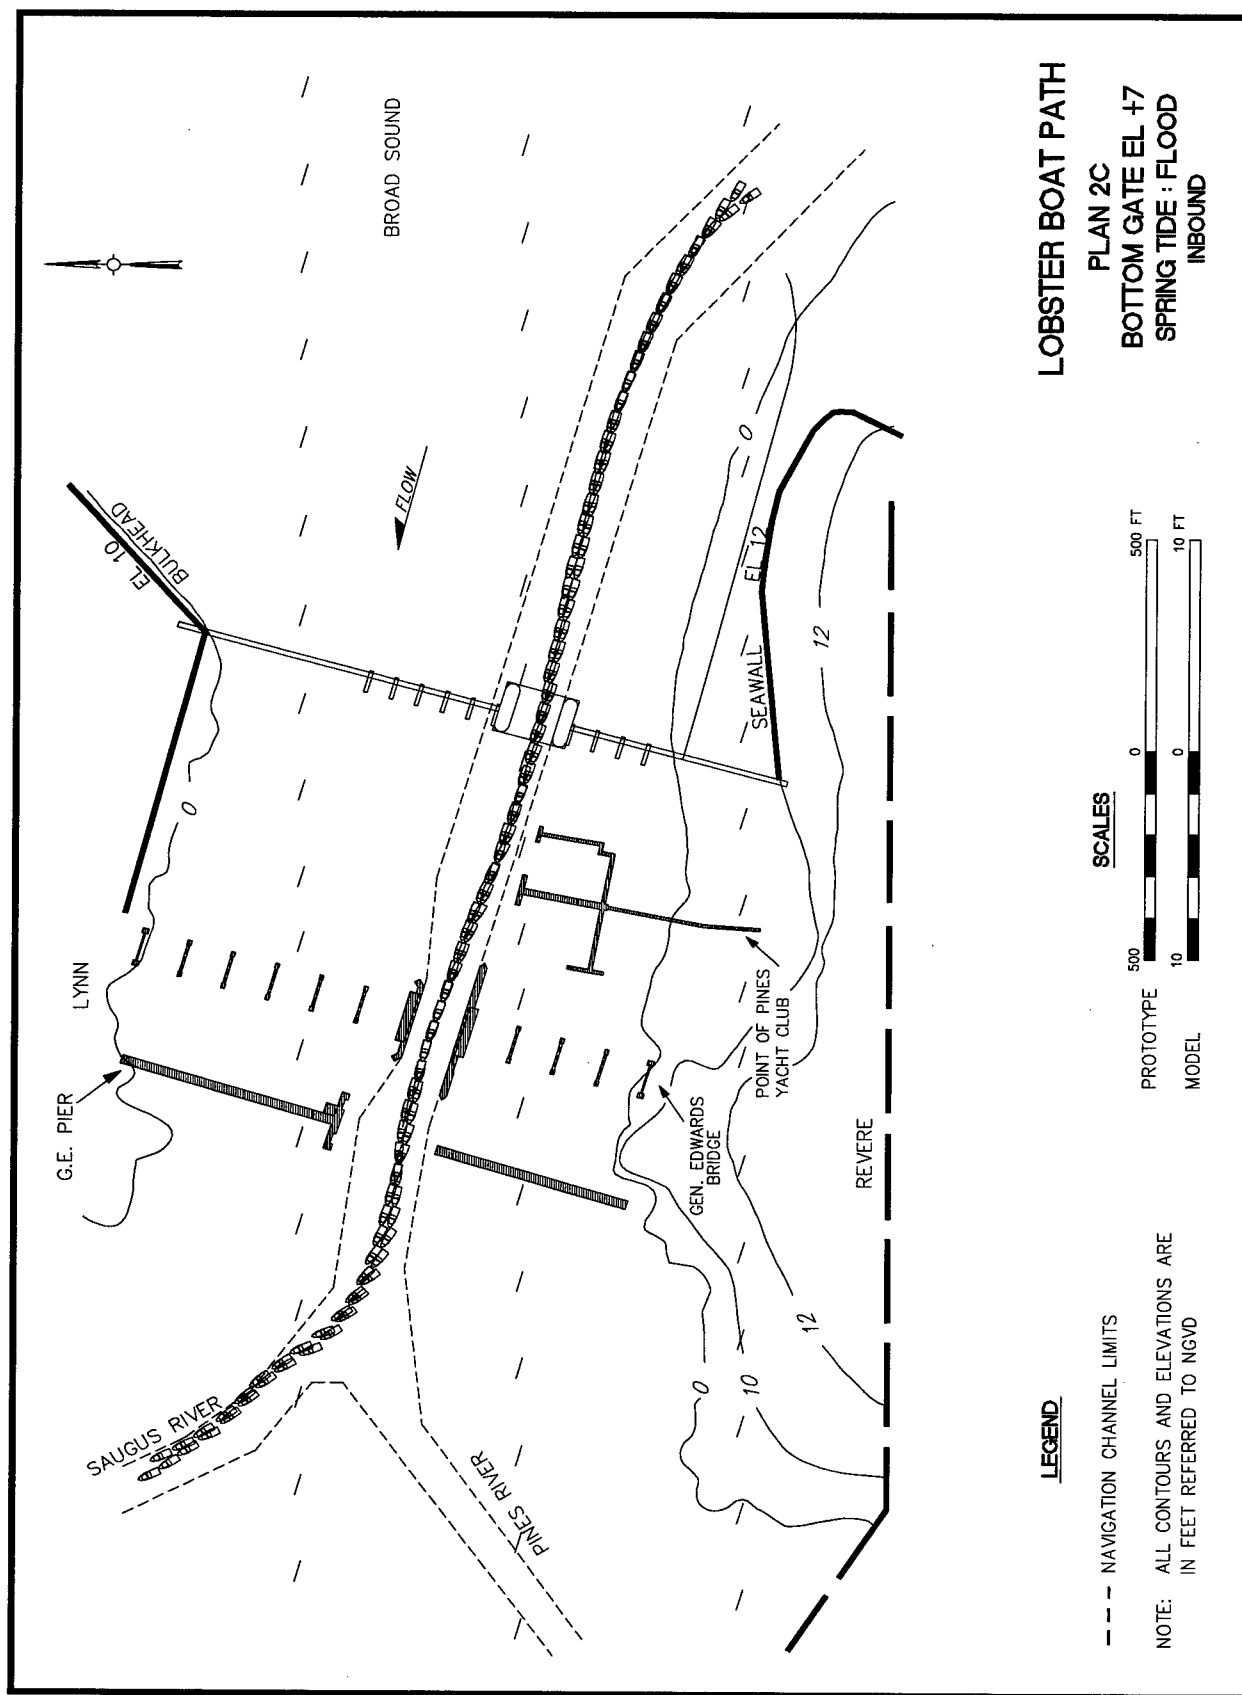
Plate 48

Navigation conditions. Navigation conditions for small vessels are demonstrated in Plates 48-51, which show multiple tracks of the remote-controlled lobster boat for the spring tide only. Navigation conditions were satisfactory for inbound and outbound traffic with the spring tide and flood flow (Plates 48 and 49). Inbound traffic could align with the navigation gate about 600 ft seaward of the flood-control structure, enter the navigation gate, align with the navigation span of the GEB, and enter and pass the GEB with no significant difficulties (Plate 48). However, it should be noted that a crosscurrent existed in the navigation channel approaching the flood control structure, and its effects (a slight drift toward the south) on inbound traffic are shown in Plate 48.

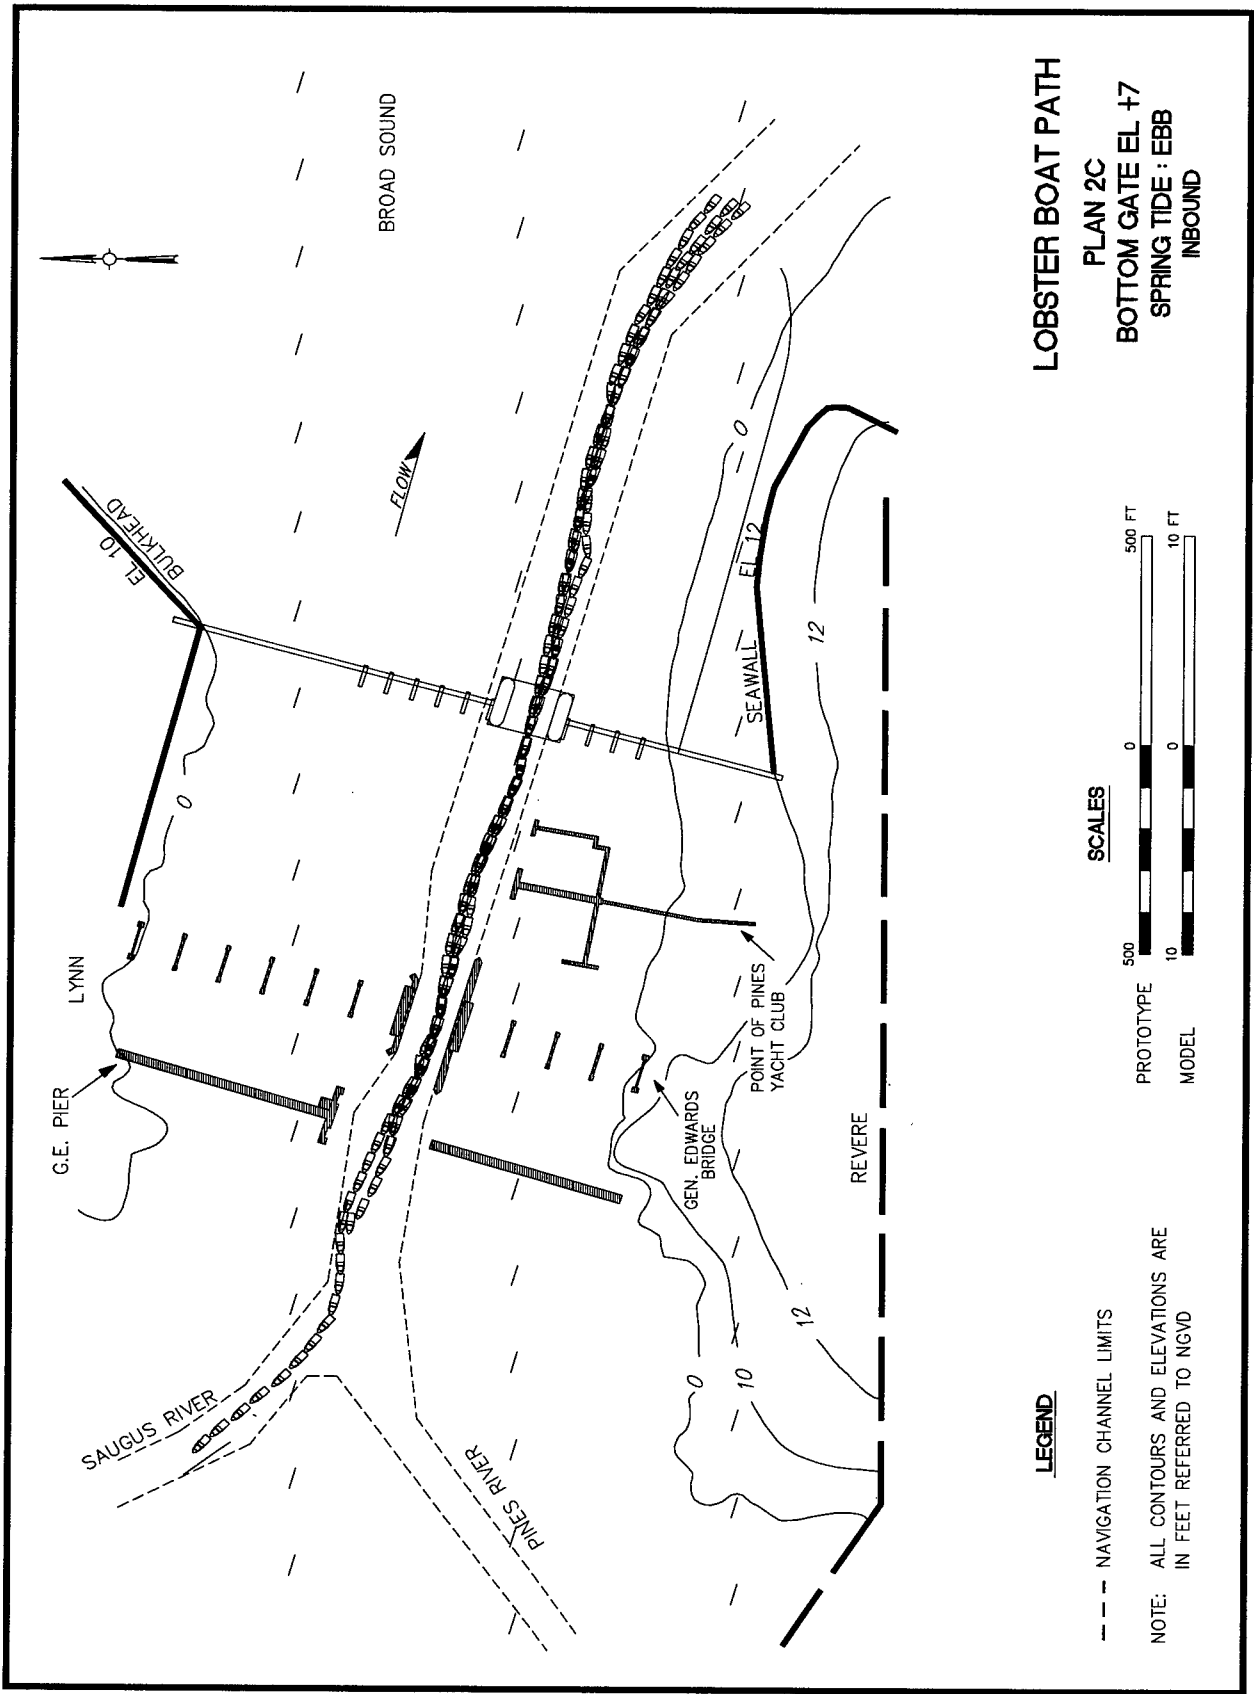
Plate 50

With the spring tide and ebb flow, navigation conditions were satisfactory for inbound and outbound traffic (Plates 50 and 51). Inbound traffic could align with the flow and pass through the navigation gate of the flood-control structure and the navigation span of the GEB with no significant difficulties (Plate 50).

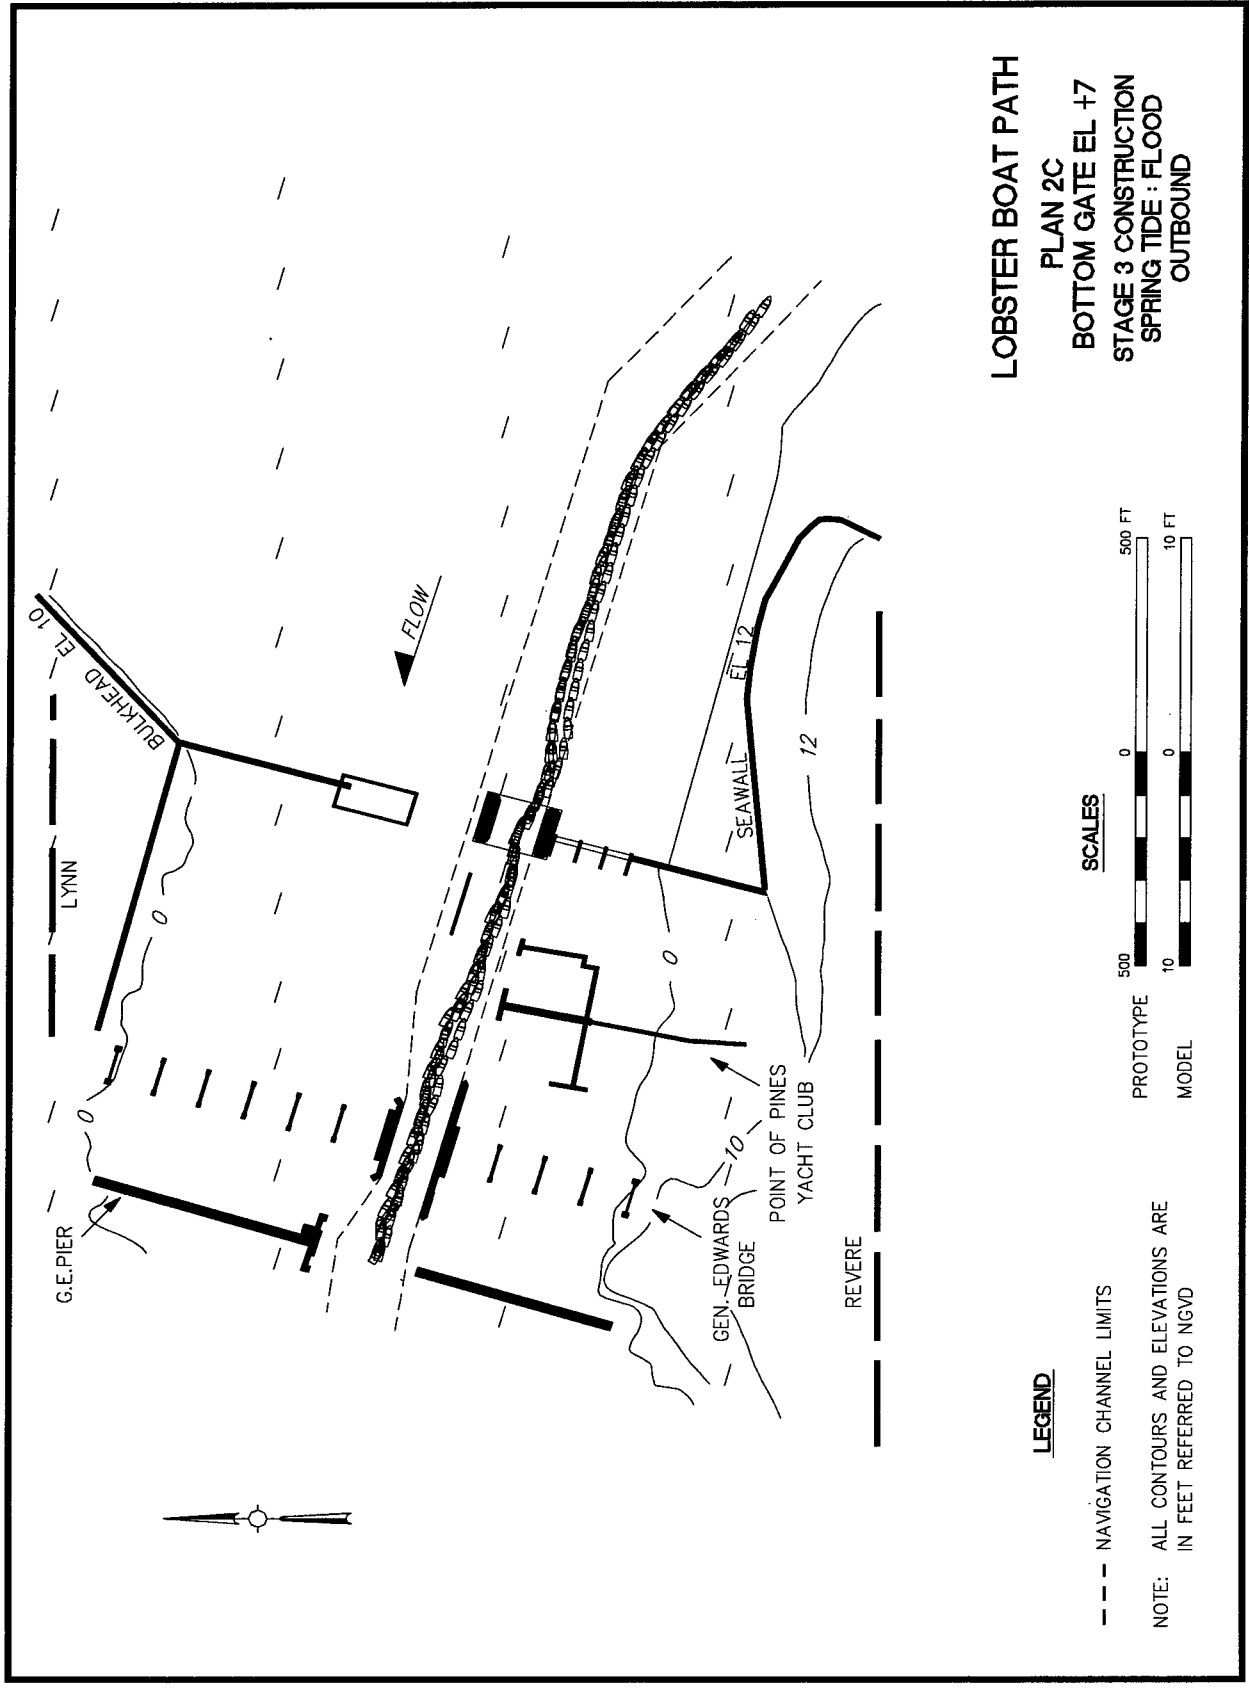
Navigation conditions, Stage 3. Navigation conditions are shown in Plates 82-89. Navigation conditions were satisfactory for both inbound and outbound traffic with all conditions tested. With Stage 3 construction, traffic was required to pass through the navigation gate, unlike Stage 2 where traffic could either go through the navigation gate or to the north side of the navigation gate. With flood flow (Plates 82 and 83), inbound traffic could approach the navigation gate from Broad Sound in about the middle of the navigation channel with no significant difficulties. However, as the boat approached the GEB, a crosscurrent developed in the navigation channel that tended to move the vessel toward the south shore and out of alignment with the navigation gate. Inbound traffic did appear to encroach on the south pier of the navigation gate especially with the spring tide (Plate 83). Once clear of the navigation gate, inbound traffic could align with the navigation span of the GEB and proceed inland with no significant difficulties. Navigation conditions were satisfactory for outbound traffic (Plates 84 and 85). Navigation conditions were a little more difficult with the spring tide than with the neap tide, because of higher velocity currents.

LOBSTER BOAT PATH
 PLAN 2C
 BOTTOM GATE EL. +7
 STAGE 3 CONSTRUCTION
 SPRING TIDE : FLOOD
 OUTBOUND

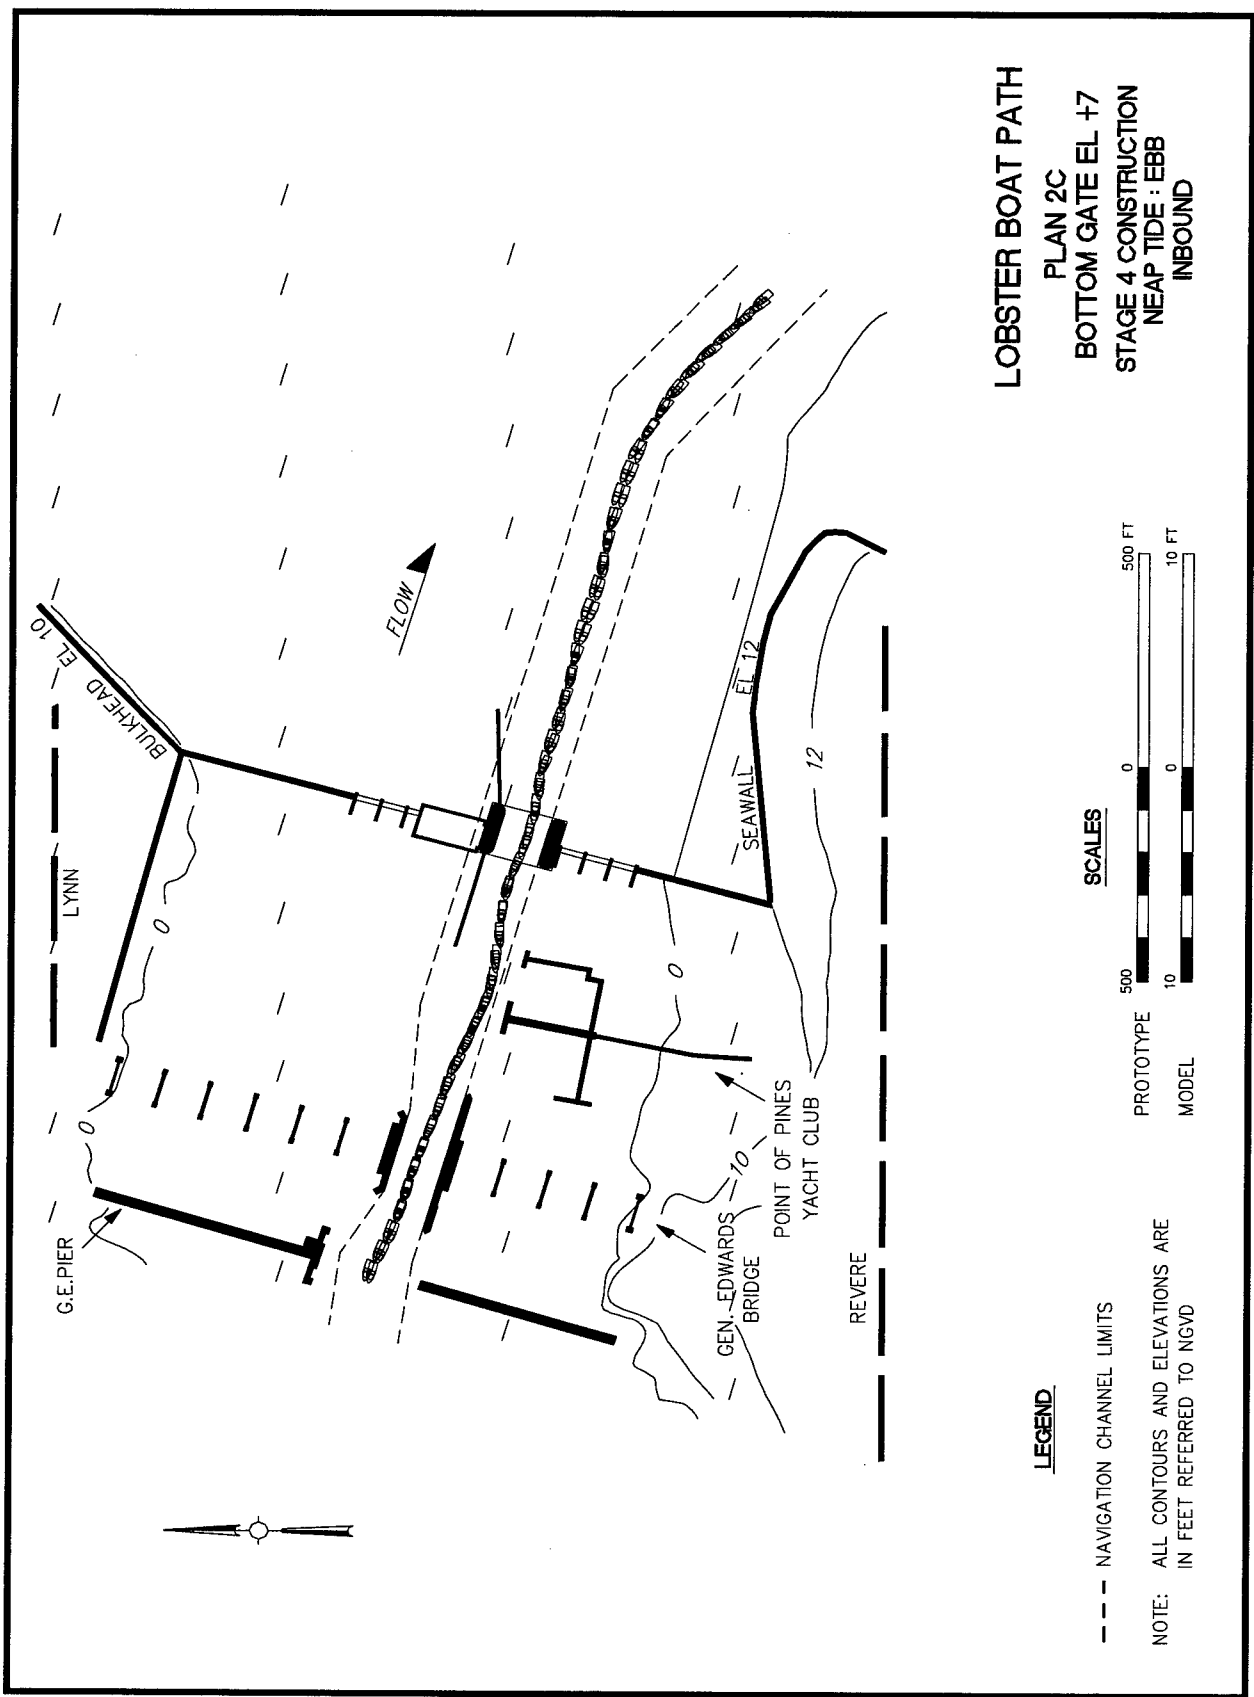
Plate 100

the navigation channel and through the navigation gate. Navigation conditions were satisfactory for inbound traffic (Plates 100 and 101). Inbound vessels could align with the flow and move from Broad Sound inland with no significant difficulties.
